EVC Drone Solutions

Severity overview

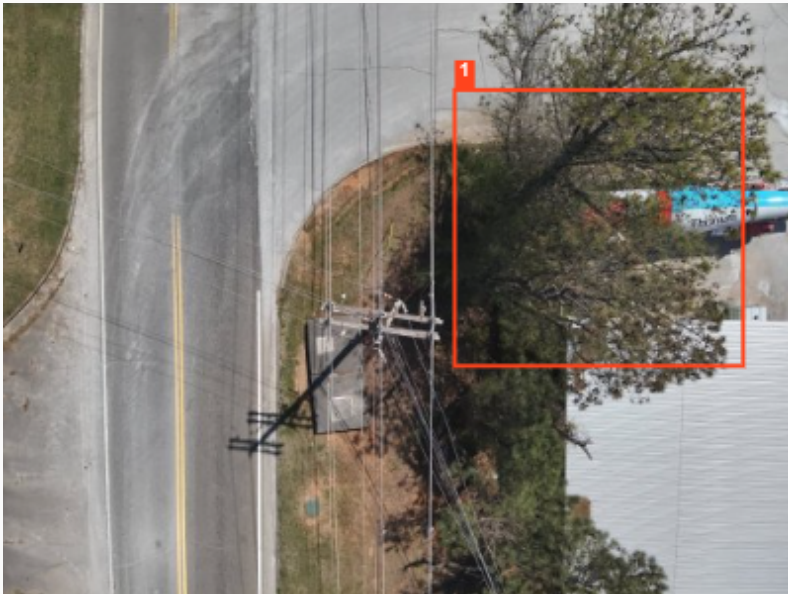
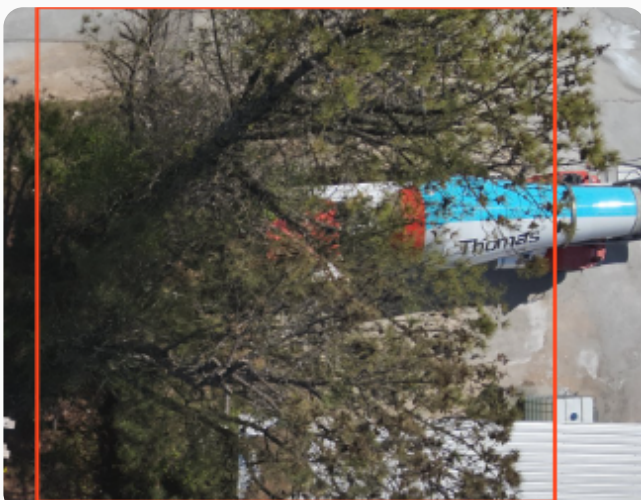
1

Severity 4

Vegetation

**Remedy Action:**
Vegetation need to be Trim

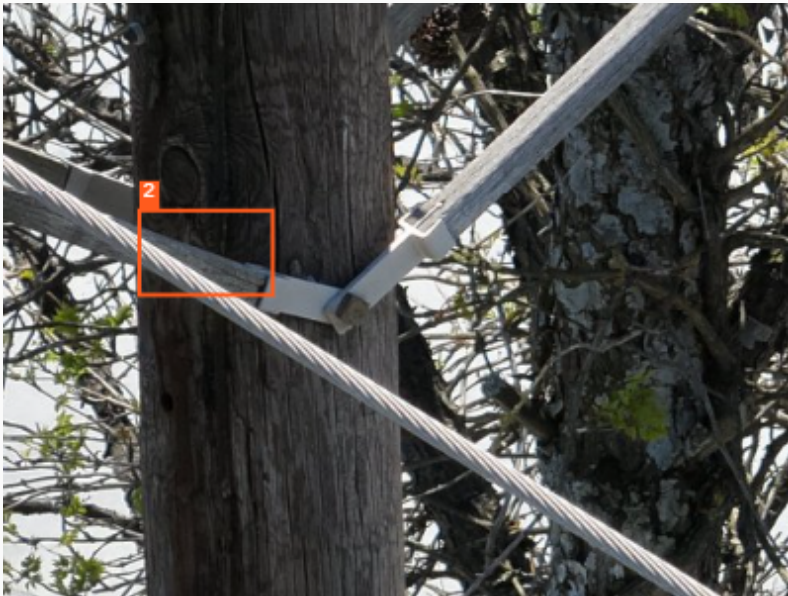
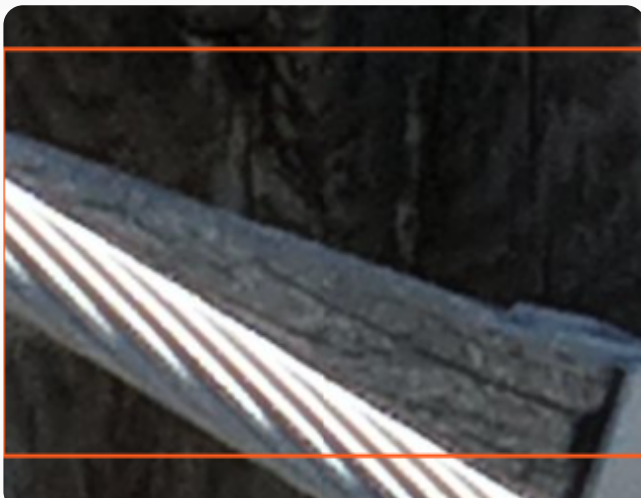
2

🚩 Severity 3

⚠️ Damage

🏗️ Structure/Wood/Cross Arm

👤 **EV**
cross arm brackets has a Crack

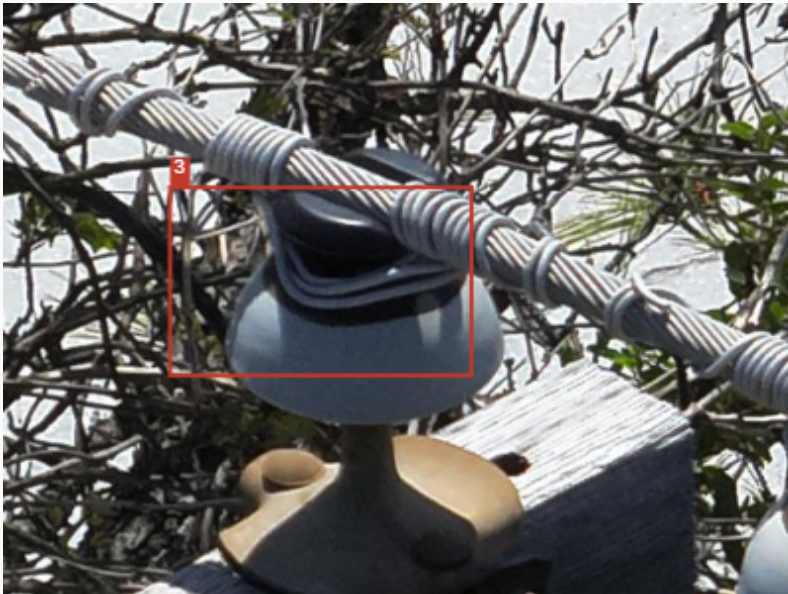
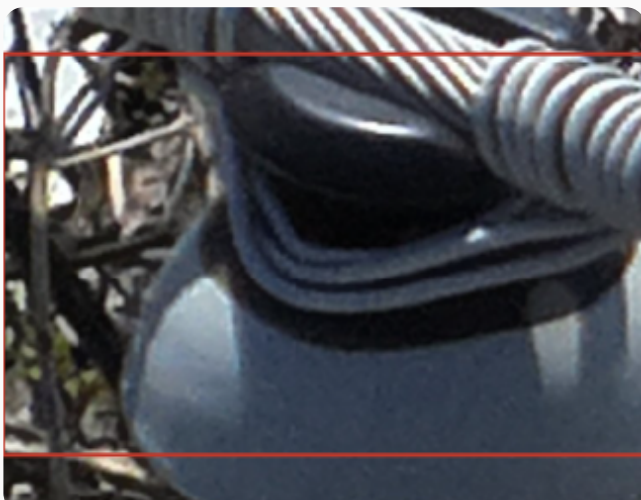
3

🔥 Severity 5

⚠️ Other Issue

🔧 Insulator/Ceramic

👤 **EV**
Tirewire is Cross

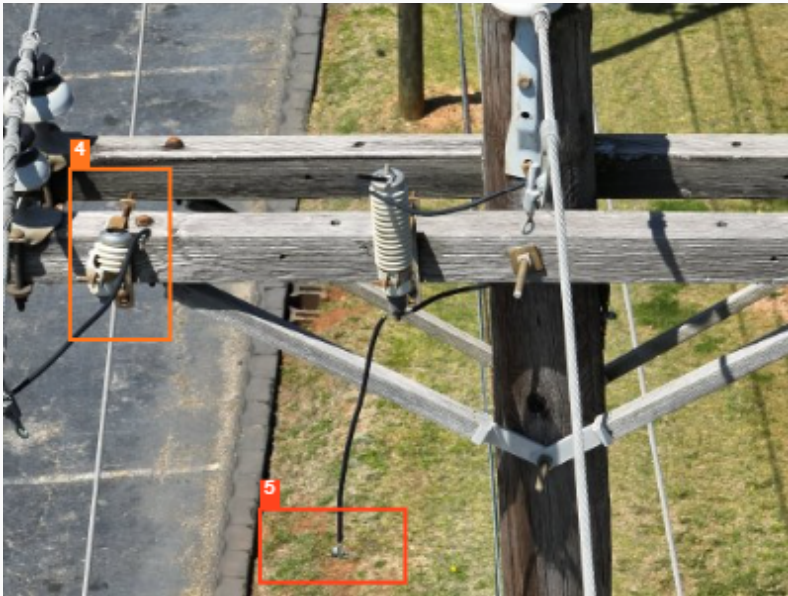
4

🔧 Severity 2

⚠️ Broken

🔌 Insulator

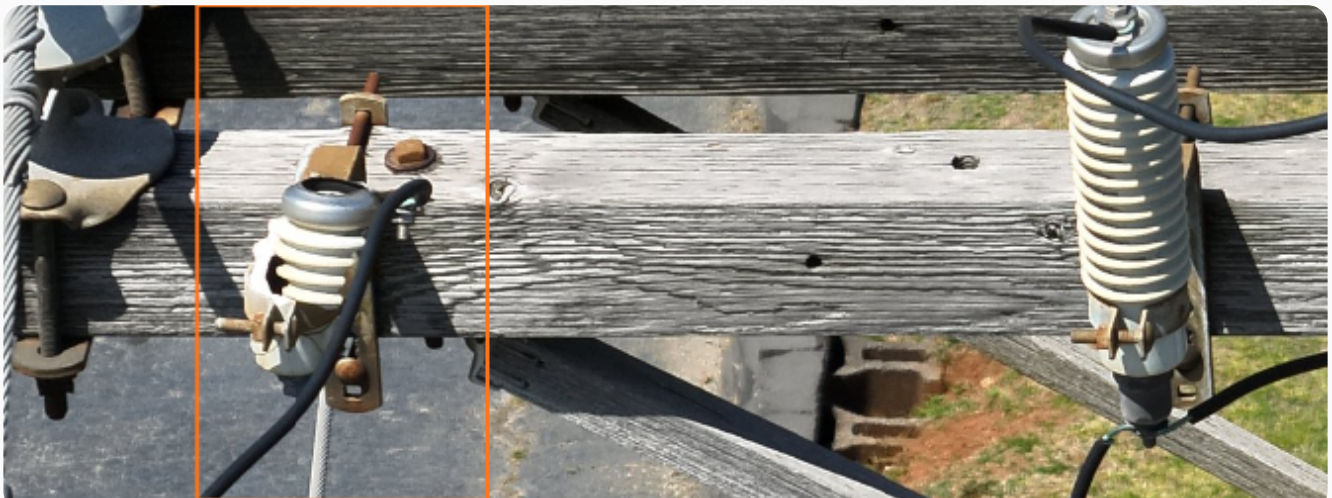
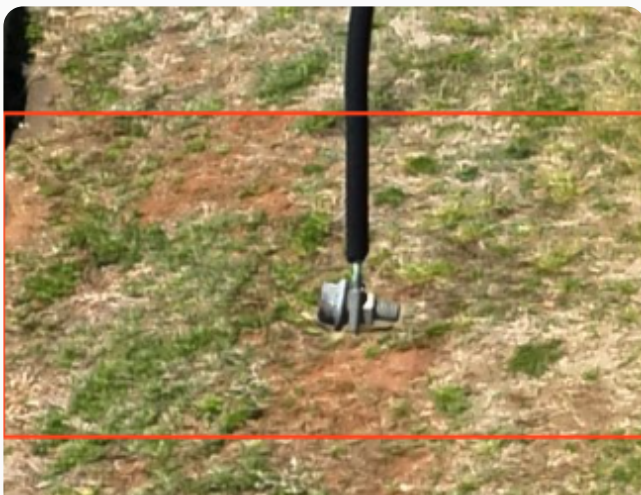
5

🔧 Severity 4

⚠️ Broken

Remedy Action:

Loose #6 copper from LA from road side
